## Photo inspection report

### Sample office entrance

DEMO-2026-0927

Client: Fictional office

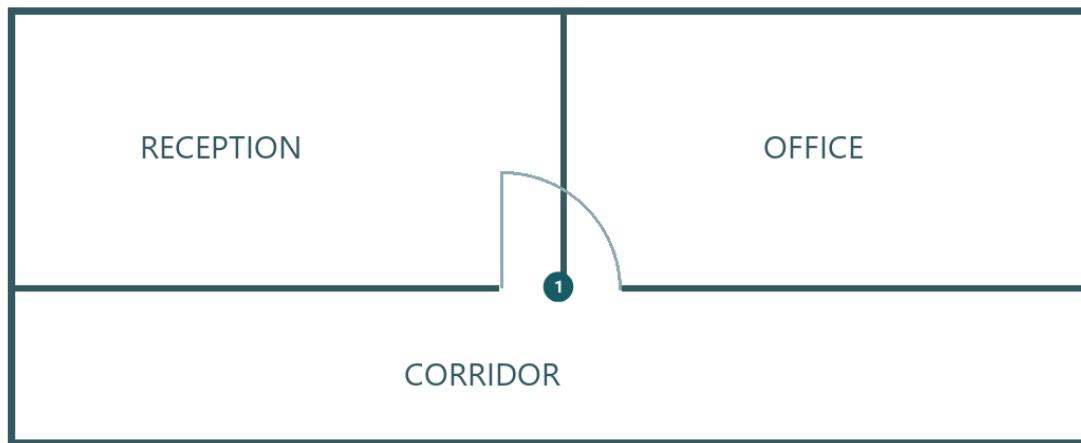
Fictional office entrance. Door finding is marked by the app.

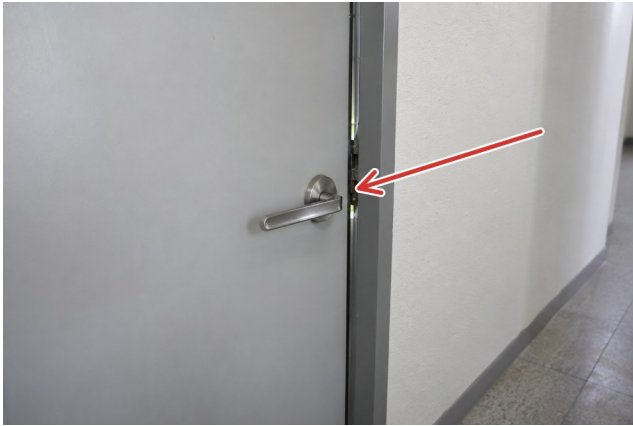
**Before**

### Finding 1 · Door alignment at entrance

Ground floor / entrance door · Resolved

Fictional demo with AI-generated photos. Before: uneven latch-side gap. After: a narrower, uniform seam.
