# Photo inspection report

## Sample office entrance

DEMO-2026-0927

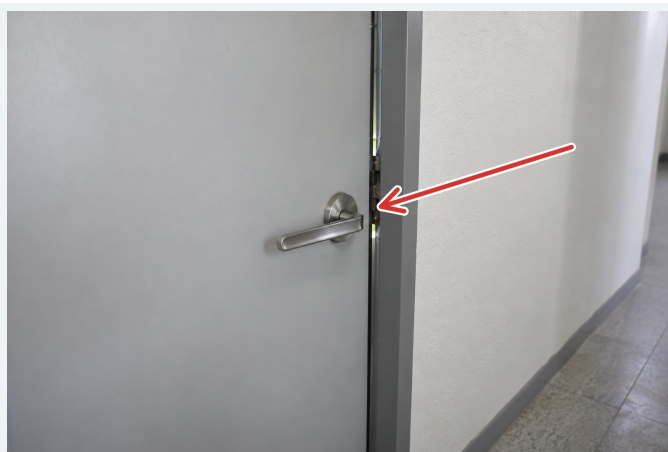
Before

### Finding 1 · Door alignment at entrance

Ground floor / entrance door · Resolved

Fictional demo with AI-generated photos. Before: uneven latch-side gap. After: a narrower, uniform seam.
